CITY OF BOZEMAN

# STORMWATER FACILITY INSPECTION PROPOSAL

Produced By Montana State University  
EENV 436 Stormwater Management Course

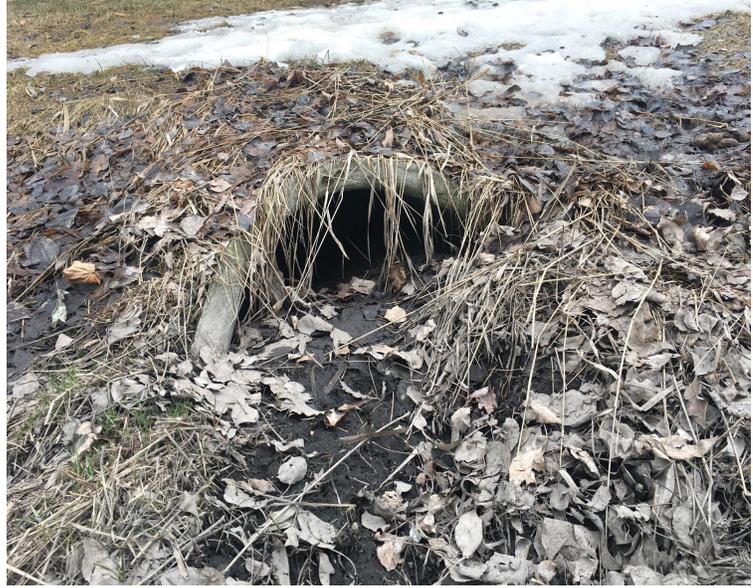
*Figure 2: Probable Rating: Extreme (11)  
Sediment buildup over 66%*

Before runoff from a development can access a stormwater facility it must be collected and transferred through an inlet structure. An inlet structure could be a hydraulically designed pipe or a simple series of berms to direct water. Either way, they were designed to convey a calculated peak flow rate. Inlets can become impeded by trash, sediment, and vegetation which can greatly alter the amount of flow that can pass through. When a structure becomes too clogged, like the photo to the right, it may start to erode and flood areas around the inlet causing significant damage.

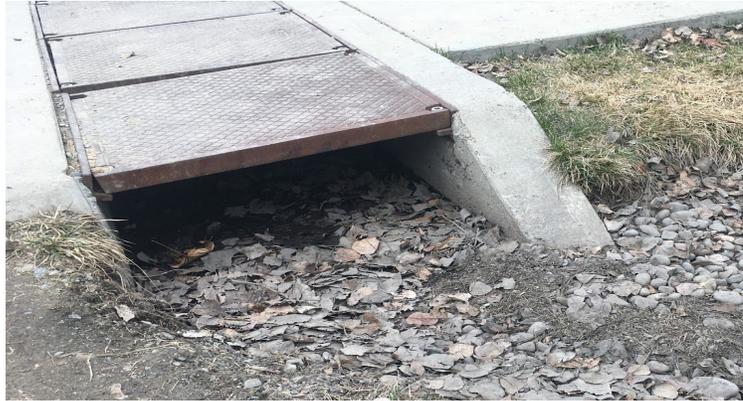
*Figure 3: Probable Rating: Fair (2)  
Some sediment and vegetation*

A simple survey shown below can be used by the City of Bozeman to analyze the condition of the facility. Once a facility has over one third (33%) of its inlet clogged it can seriously affect the hydraulic function it was originally designed to perform. A poor or extreme rating needs to be addressed immediately and the HOA needs to be alerted. The image to the right shows an example of some sediment and vegetation buildup.

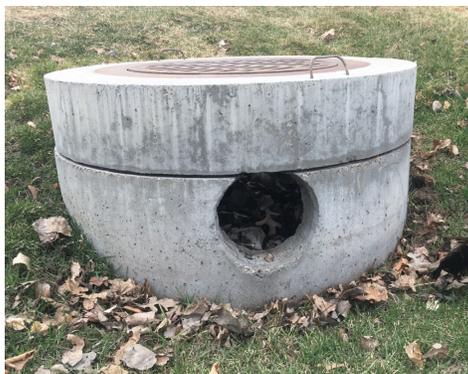
*Figure 4: Probable Rating: Good (1)  
Slight debris in outlet structure, easily accessible, opening is not covered*

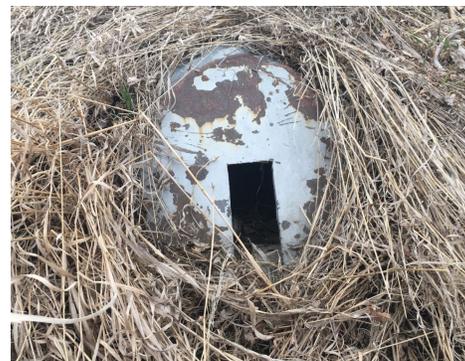
*Figure 5: Probable Rating: Poor (3)  
Surrounding vegetation would likely impede pond function*

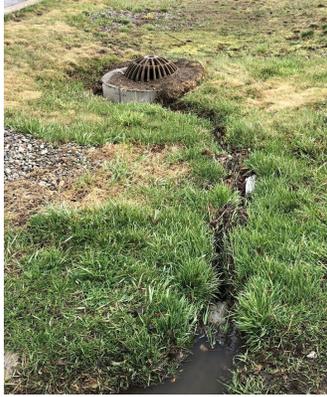
*Figure 6: Probable Rating: Poor (3)  
Erosion around outlet structure*

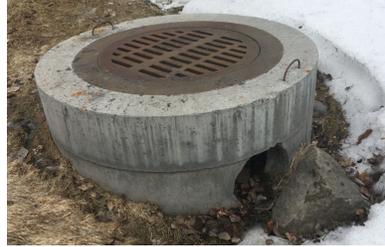
*Figure 7: Probable Rating: Fair (2)  
Large obstruction near opening*

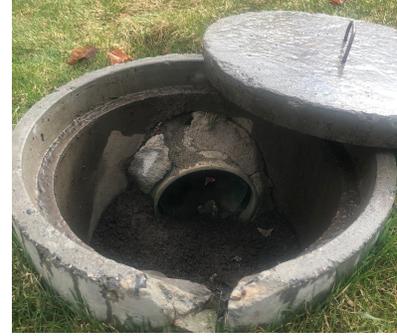
*Figure 8: Probable Rating: Fair (2)  
Sediment build up in basin,  
structure degrading*

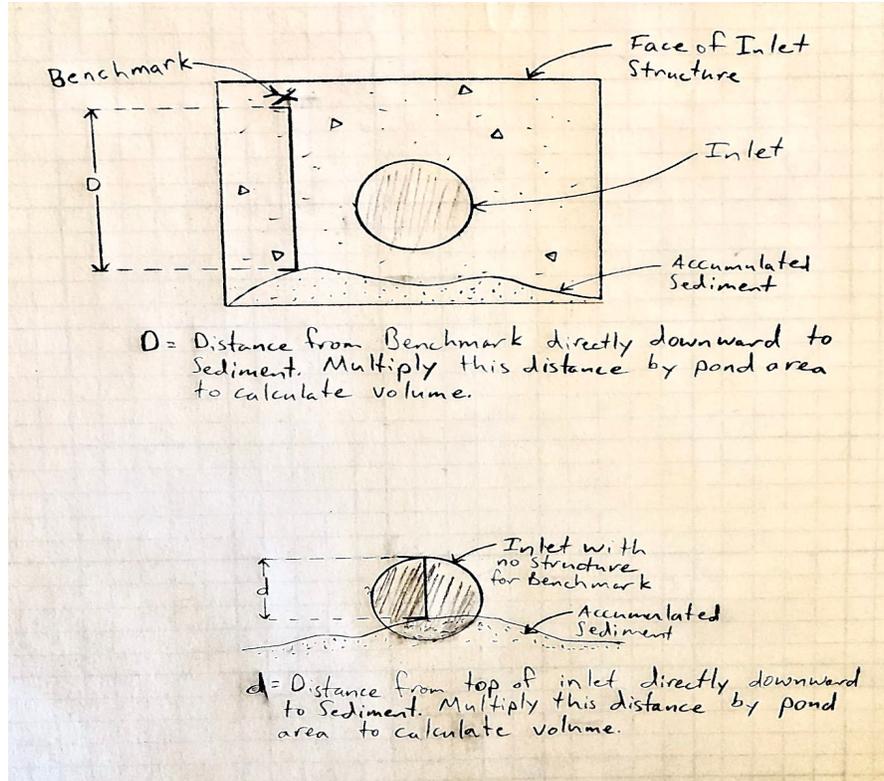
Figure 9: Example of measuring distance to sediment, with (top) and without (bottom) structure.

To measure the reduction in storage caused by sediment buildup in an individual pond, the distance from a benchmark to accumulated sediments needs to be measured and multiplied by the surface area of the pond. For the purpose of this assessment tool, this calculation will be an estimate only and not an exact number.

Multiply the distance measured from the benchmark to the sediment by the pond area. This results in an approximate volume of water. By recording the results of this calculation during each inspection of an individual pond, approximated changes in storage volume can be monitored.

A permanent marker or hard, sharp object (such as a nail) is needed to mark the Benchmark on the inlet structure at each detention pond, if the structure has a surface or available area to mark (see above if there is no surface). While this is only required for the first inspection of an individual pond, it may be necessary to re-mark the benchmark in case of fading or deterioration of the original mark.

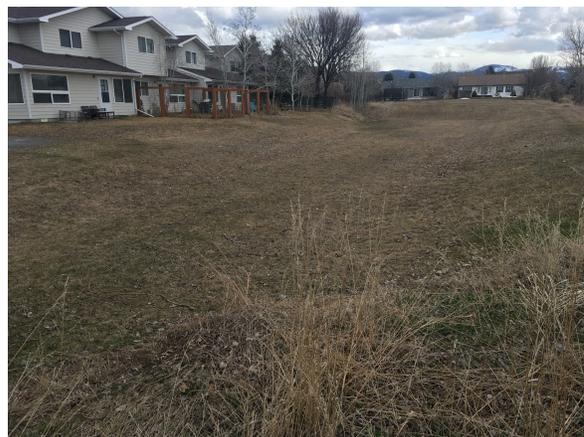
Figure 10: Probable Rating: Good (1)  
Short grass with no bare ground

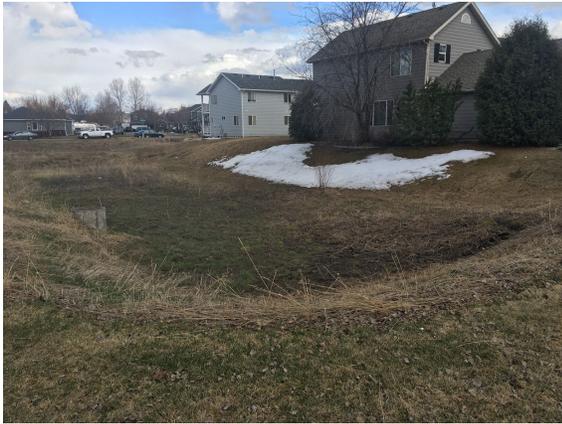
*Figure 11: Probable Rating: Fair (2)  
Pond bottom is clear but pond sides have  
overgrown vegetation*

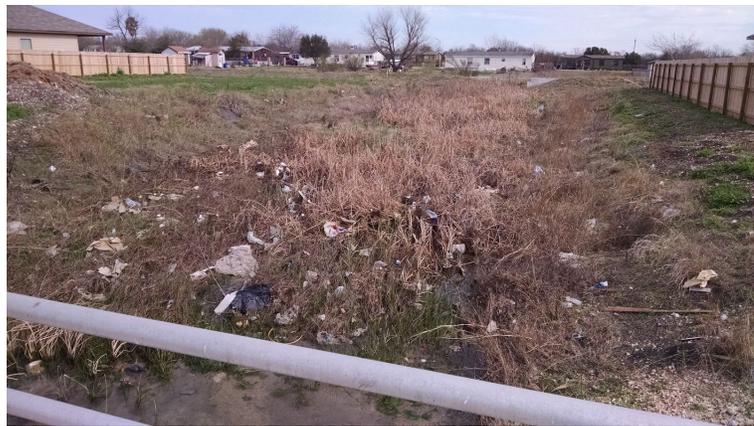
*Figure 12: Probable Rating: Poor (3)  
Overgrown vegetation prevents drainage*

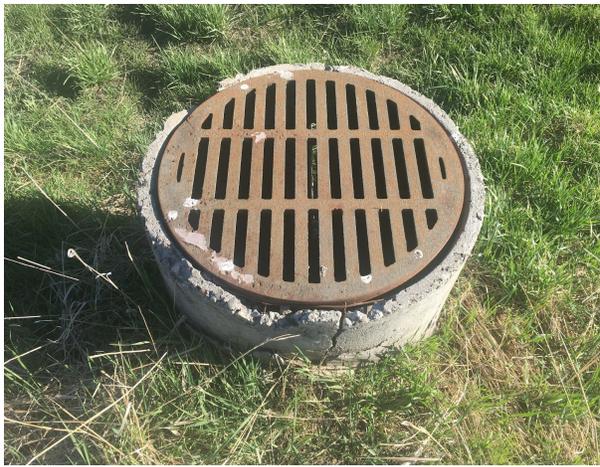
Figure 13: An outlet structure in poor condition. Significant cracking and rebar showing.

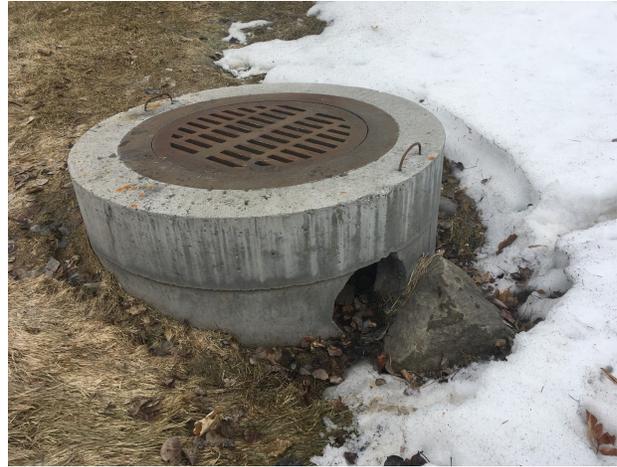
Figure 14: An outlet structure in good condition. No noticeable cracking.
